Re: 2011 Project Completion Report - Aquatic Management Program at Lake Singletary.

Lake Singletary

Milbury / Sutton, MA

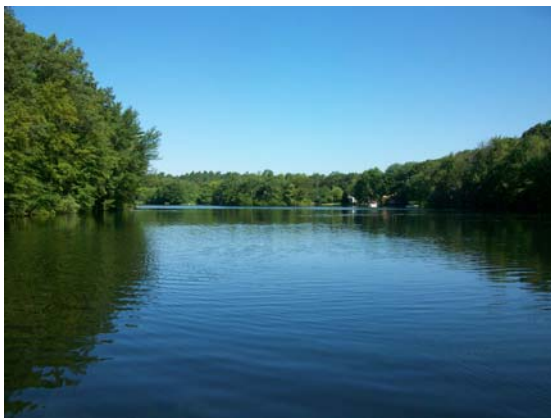
Early Season Survey - Observed
Aquatic Plant Assemblages

The survey revealed patchy, and dispersed fanwort throughout the littoral zone. Fanwort was common in water depths greater than 9 feet and could be found in depths as great as 14-15 feet. Eurasian milfoil was observed primarily in the cove located to the south of the small island with the red bridge. A small low

density patch of variable milfoil was observed on the southwestern shore.. Dominant native plant species observed included snailseed pondweed (*Potamogeton bicupulatus*), thin-leaf pondweed (*Potamogeton pusillus*), Robbin’s pondweed (*Potamogeton robbinsii*), naiad (*Najas flexilis*) and tapegrass (*Vallisneria americana*). Macro-algae, stonewort (*Nitella* sp) and filamentous algae were also observed in moderate densities throughout the littoral zone (figure 1).

- We continue to recommend hand-pulling for low density fanwort growth in order to hinder its spread and to complement the drawdown effort. Hand-pulling areas should be prioritized to prevent low density areas of fanwort from becoming well established and expanding.
- During the late season survey a few purple loosestrife plants were noted along the shore. Due to the widely scattered density of the current infestation, we recommend residents look for these shoreline invasives and remove them before the populations become dense.

- We would recommend continuing with the use of Reward for the control of milfoil and native plants reaching nuisance densities as this has been successful in the past
- We recommend the use of a copper-based algaecide treatment to maintain desirably low levels of microscopic algae on an as needed basis.
- Flumioxazin (trade name: Clipper) was federally registered for aquatic use this past winter. The registration process in Massachusetts will need be completed prior to use in Lake Singletary. Aquatic Control Technology utilized Clipper in several lakes and ponds outside of Massachusetts this summer for the control of fanwort with great success.

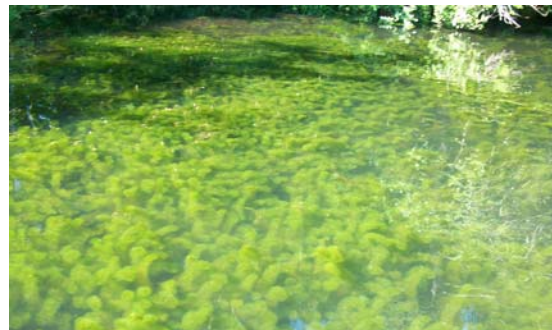
Fanwort reaching the surface in the shallow water of Harris Cove

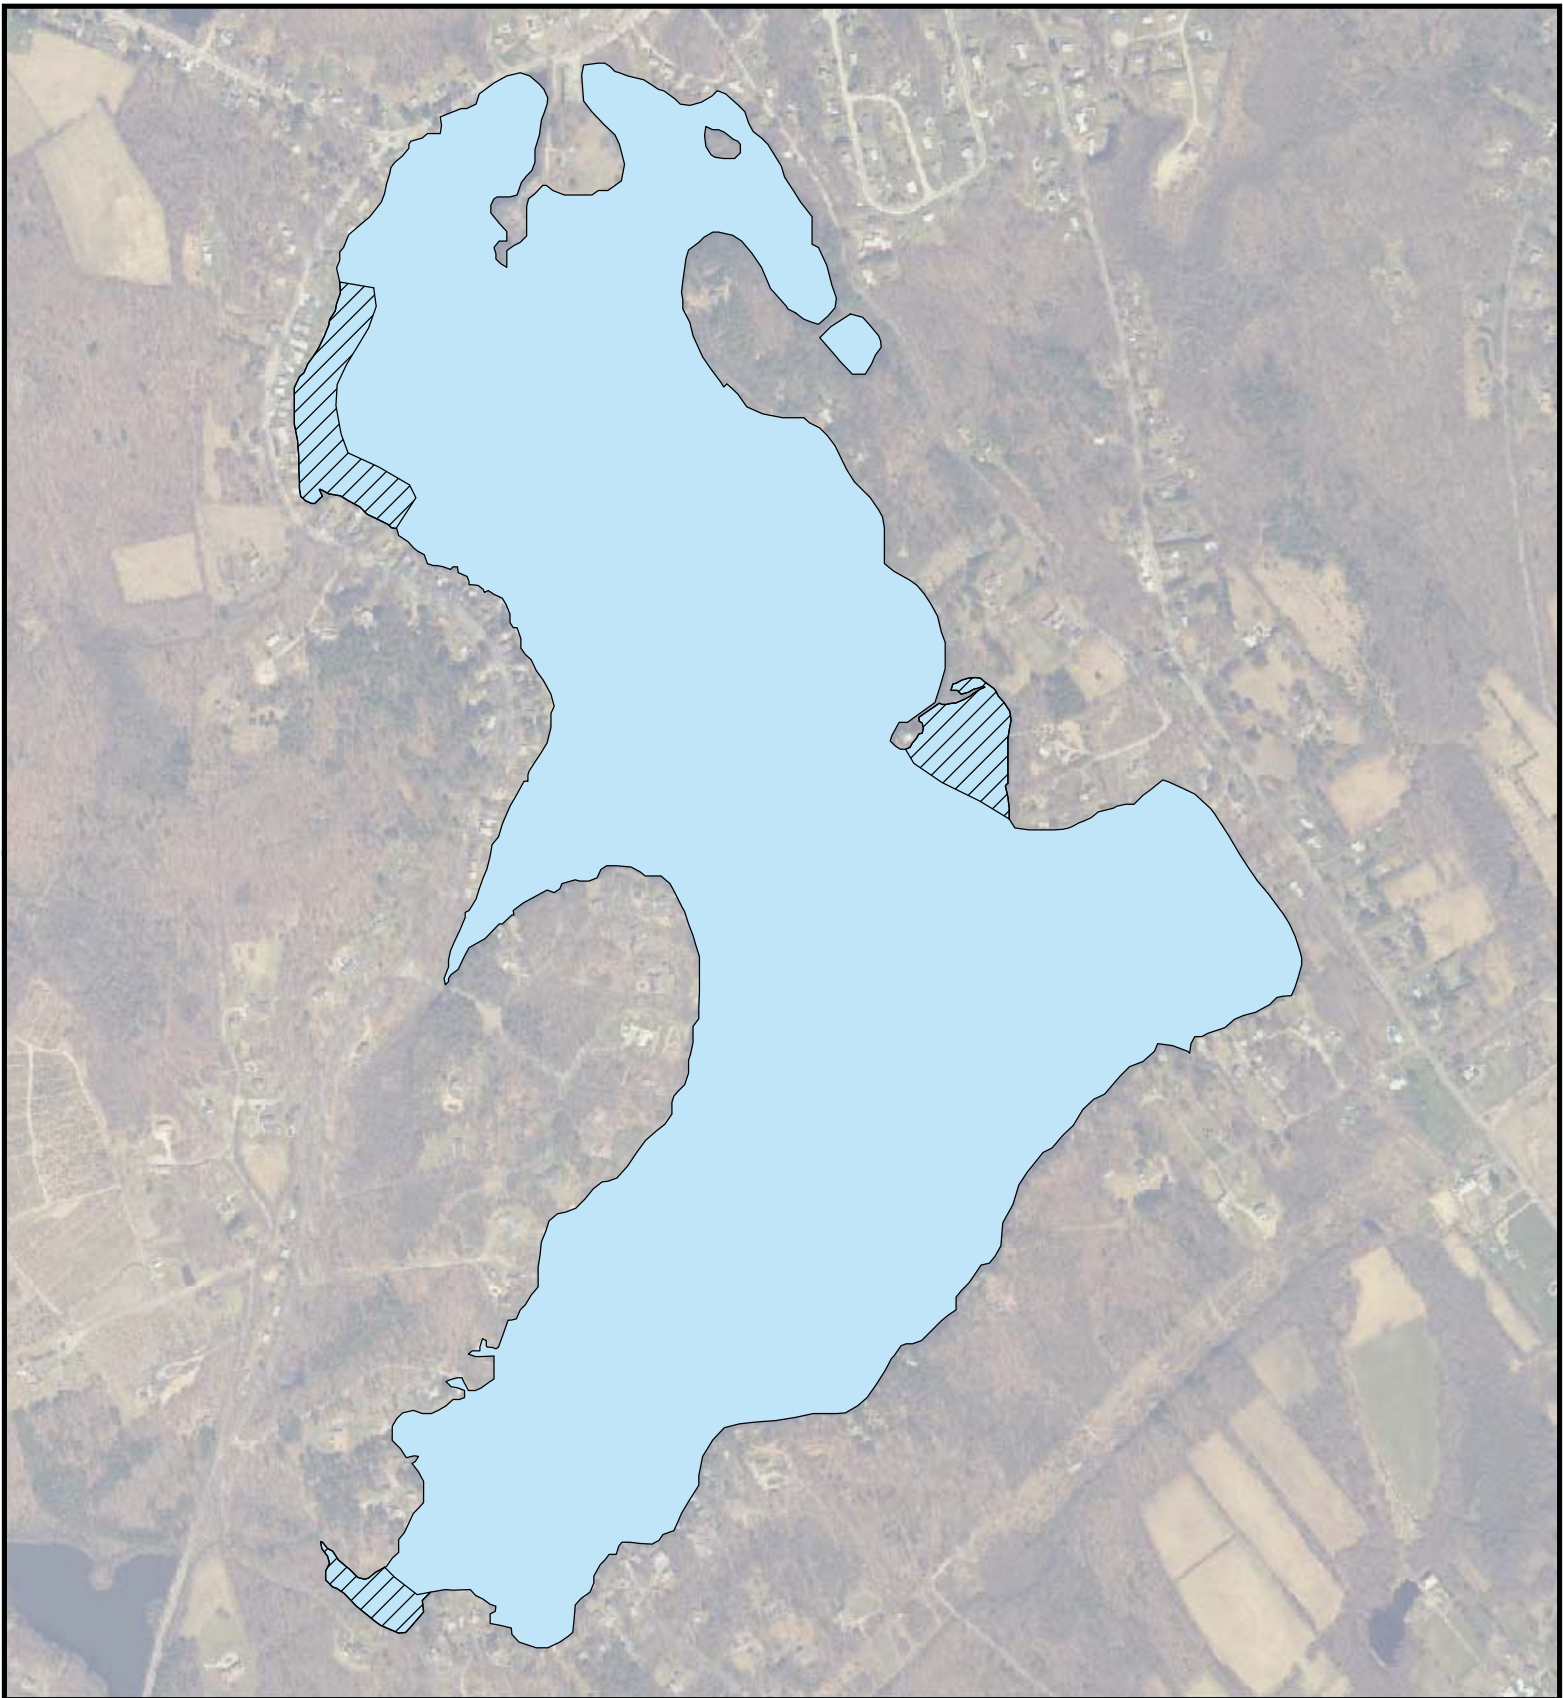
FIGURE:	SURVEY DATE:	MAP DATE:
2	07/27/11	11/08/11

Based upon the results of the early season inspection and discussions with the association, a Reward (diquat) herbicide treatment was performed on July 27th. The treatment targeted control of all invasive Eurasian milfoil and select areas nuisance level growth of native species where recreation was being negatively impacted. Approximately 14 acres were treated in total.

2011 Milfoil and Native
Vegetation Treatment

The Reward treatment program effectively controlled target species in all treatment areas. While some regrowth of native species was noted within treatment area the growth was all well below the surface and should not have had a negative impact of recreation for the remainder of the season. The Eurasian milfoil in the cove to the south of Fire-Island was completely controlled.

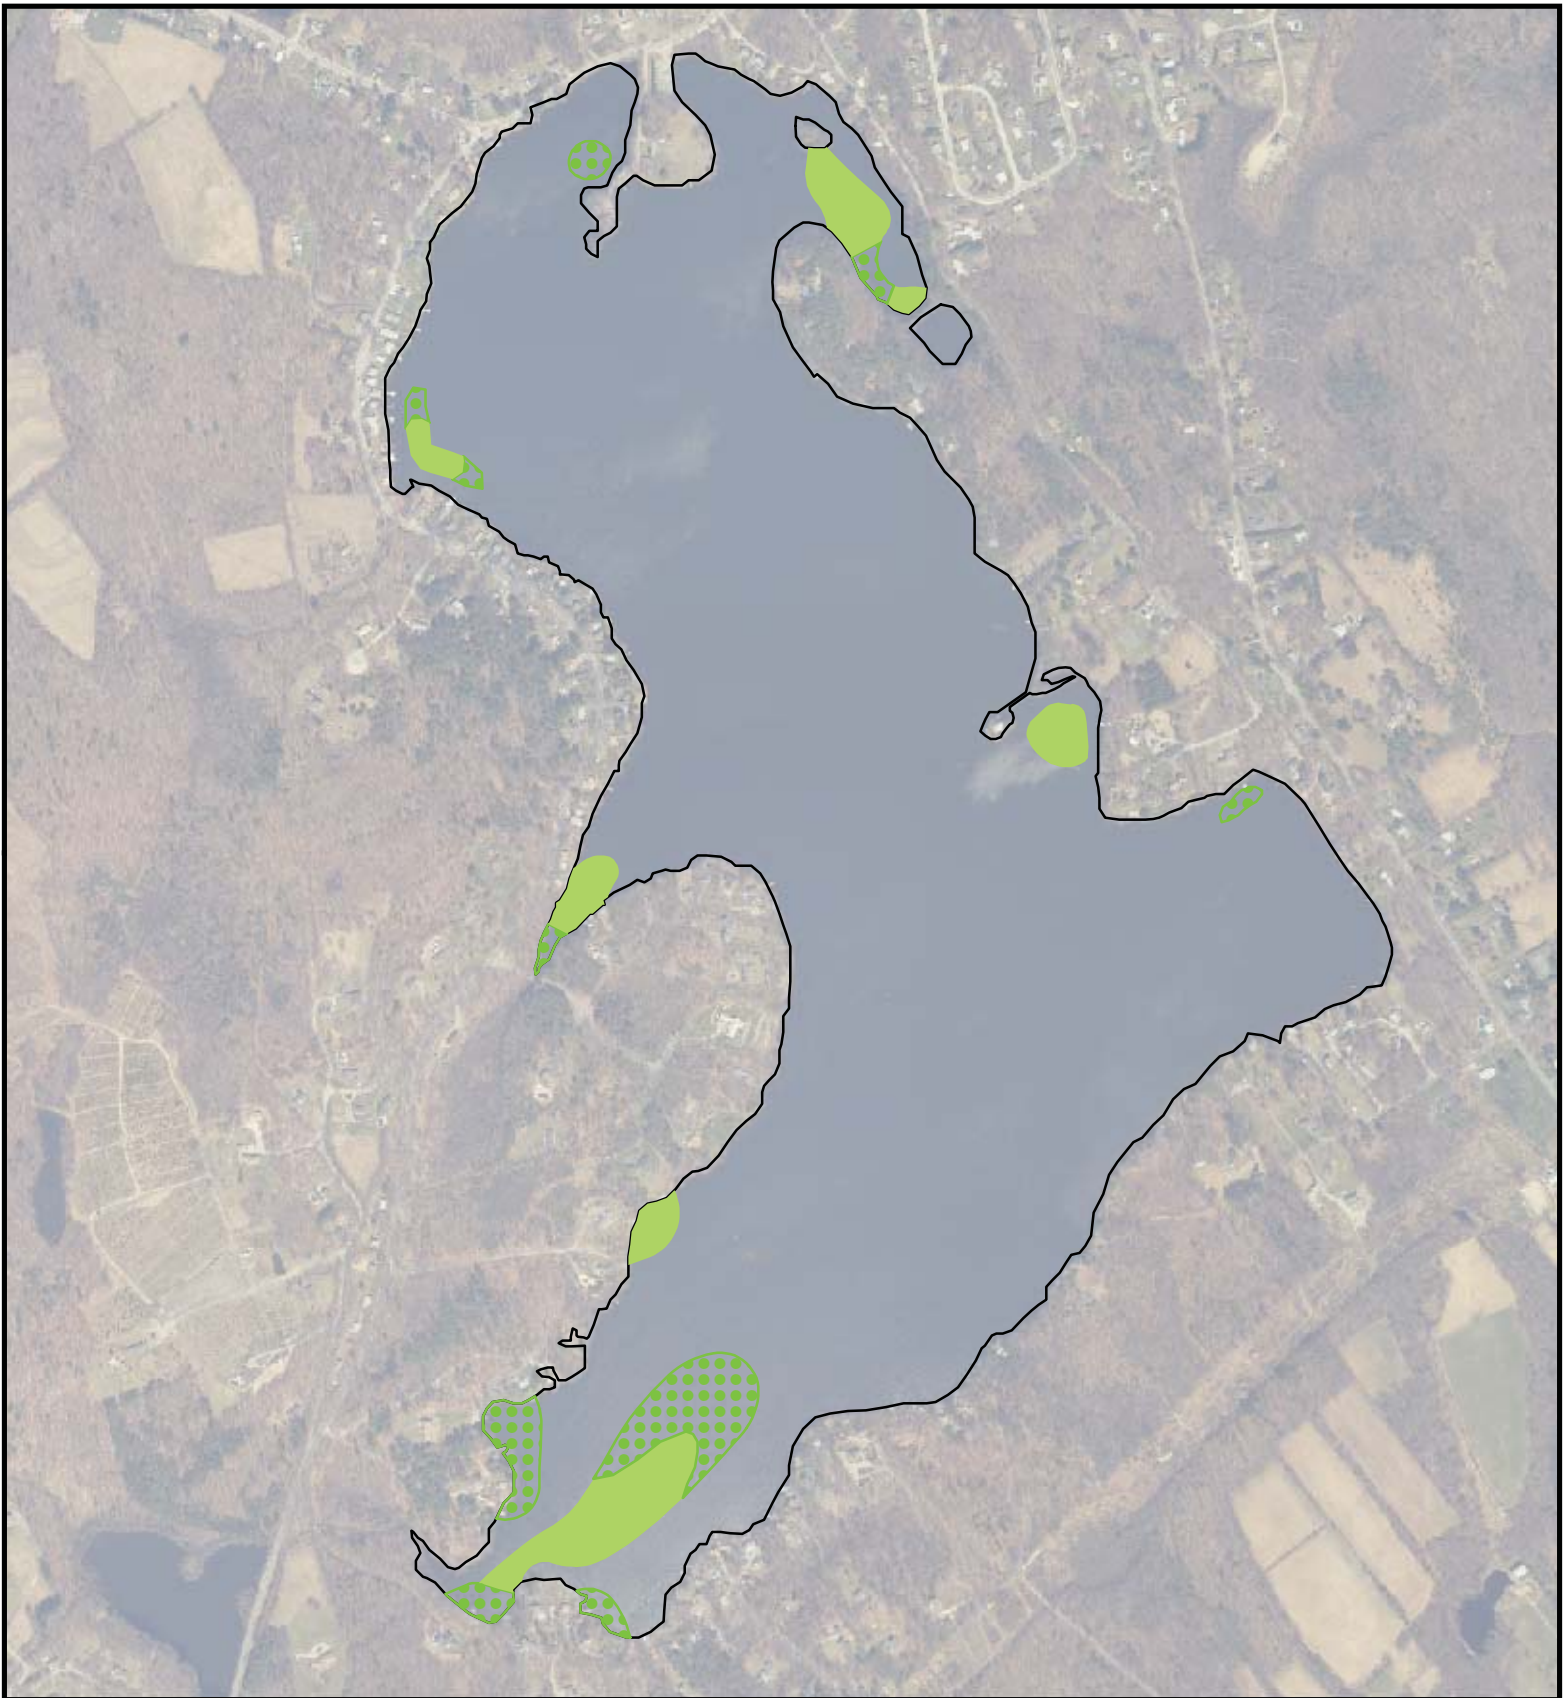
FIGURE:	SURVEY DATE:	MAP DATE:
3	08/17/11	11/23/11

Overall the fanwort growth had expanded significantly since the July surveys (figure 2). Infestations not observed in the July surveys were noted adjacent to 23 Singletary Road, in the cove bounded by Singletary Ave and Point Way and in the shallow end of Harris Cove. A guide for prioritizing hand-pulling was provided to the Association. The Association elected not to pursue hand-pulling this past year.

2011 Fanwort Observations
